Stream Continuity Assessment in the Taunton Watershed

June 2017

Stream Continuity Assessment in the Taunton River Watershed

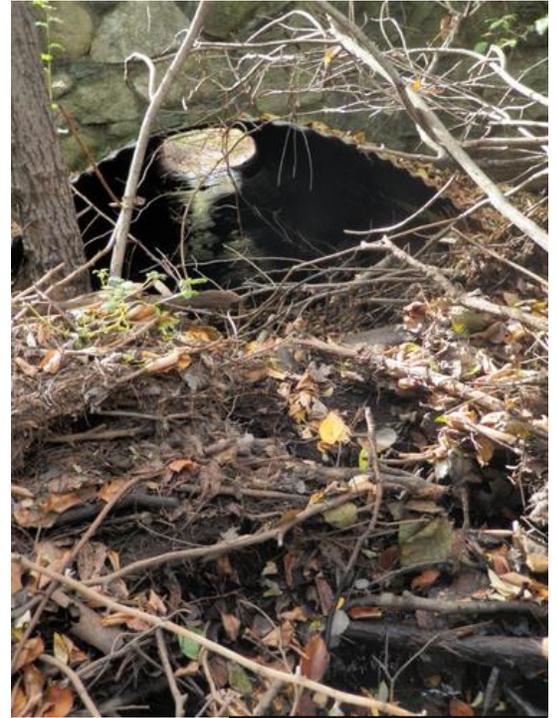
Clogs from debris like this can also inhibit passage of fish and other wildlife

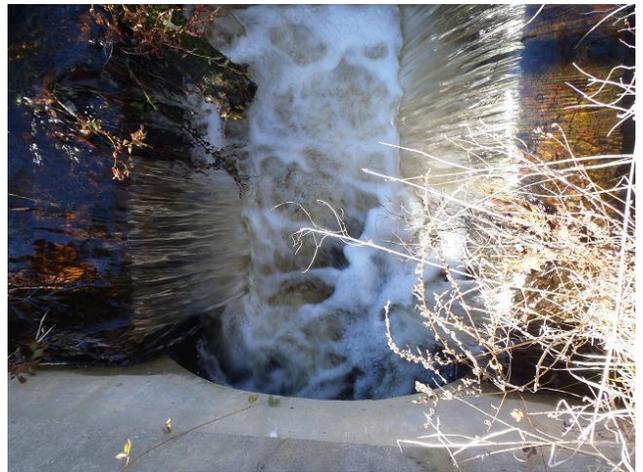
An example of a drop in elevation at Fall Brook, North Walker Street, Taunton

7. The crossing of **Fall Brook at North Walker Street in Taunton** is a single narrow culvert with a large inlet drop of 36." The crossing consists of a single culvert that acts as a dam, creating a severe restriction and large scour pool. The dam is at the upstream end of the crossing. This brook originates and flows through a BioMap2 Core Habitat Area and discharges into the Three Mile River.

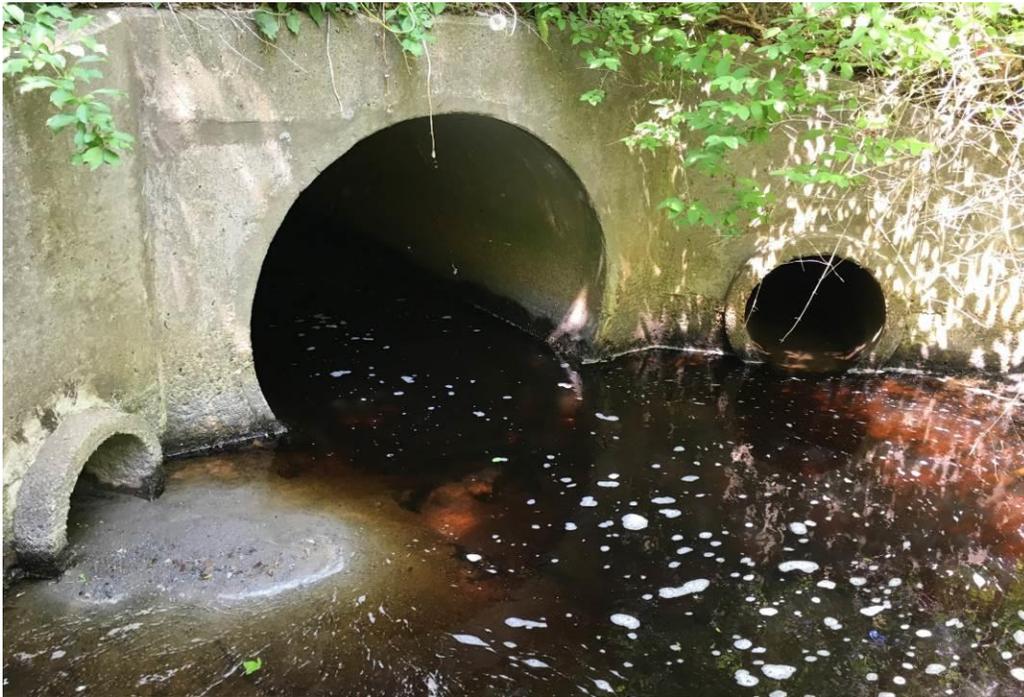
An example of a site stressed both by the culvert and stormwater (the two smaller pipes shown here are for stormwater discharge; note the large mound of sedimentation below the one on the left).

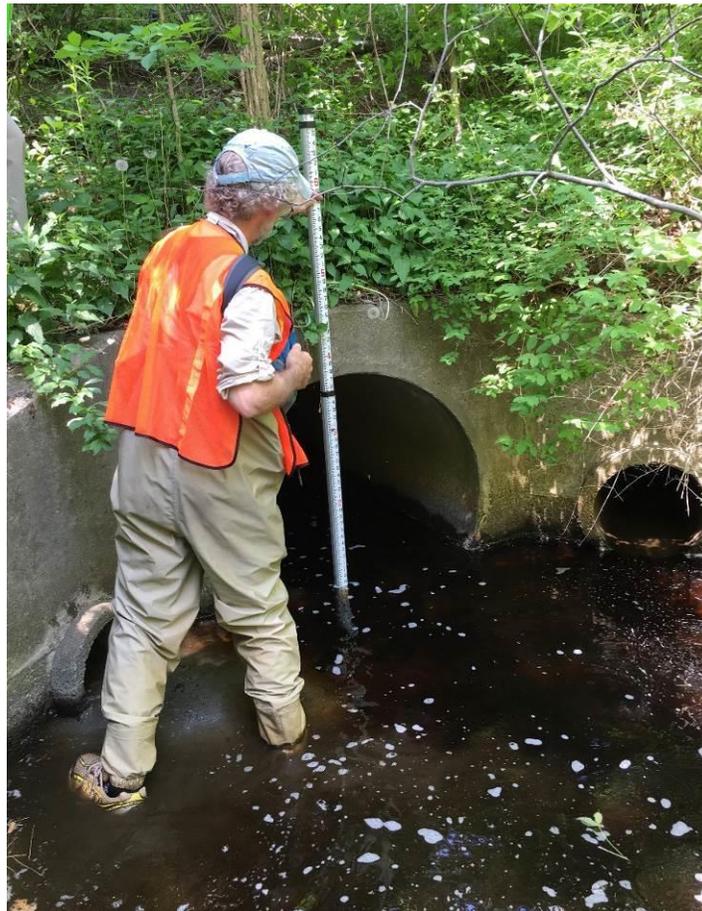
Measuring a crossing.

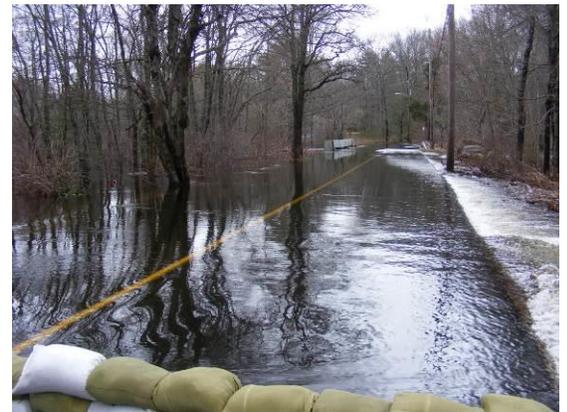
This section of the Wading River crossing at Walker St. in Norton flooded the road in 2010. Photo credit: Jennifer Carlino.

River on Walker Street in Norton that has experienced severe flooding problems but was evaluated as a minor barrier to passage in this project. Among the parameters evaluated in the field surveys, a number of them may help identify crossings that are causing localized problems. Summaries of the results for four critical parameters: crossing condition, crossing span, crossing alignment and presence of inlet or outlet drops are provided below.

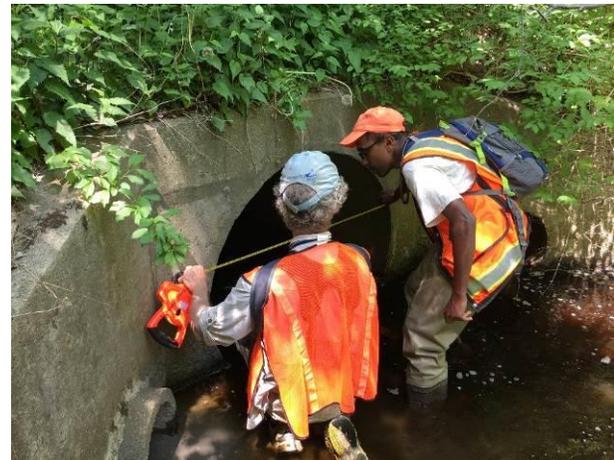
Measuring the culvert at North Walker Street in Taunton

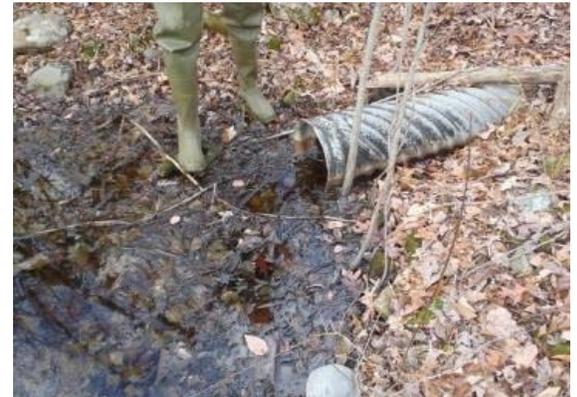
Crossings of four tributaries to the Segregansett River in Dighton on Wheeler, Horton and Maple Streets. These crossings are located within three miles of each other in an area that includes the Poppasquash Swamp, and all of them received Imp_In scores above 0.2. Two crossings on Wheeler Street received scores of 0.3454 and 0.2973. A crossing of the Poppasquash Swamp River on Horton Street received a score of 0.3243, and a crossing of another tributary to the Segregansett on Maple Street received a score of 0.2224. Especially considering the high Impact_In scores, potential cumulative benefits of restoring all four crossings should be evaluated.

*This undersized culvert at the Maple St. crossing of the Segregansett River restricts water flow and fish passage.
Photo credit: Rachel Calabro*

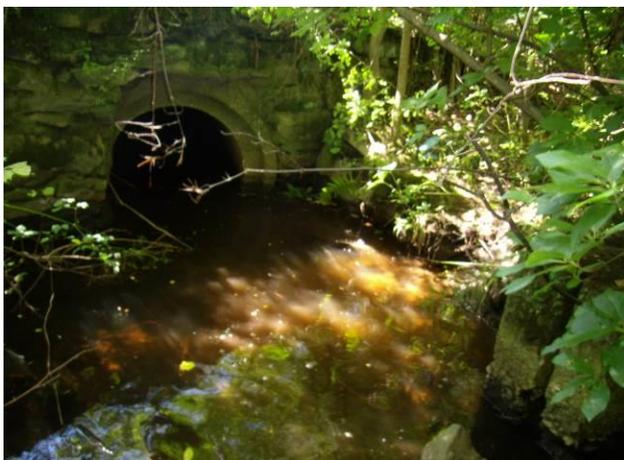
Miller Road in Middleborough

Crossings of Tamett Brook on Betty's Neck Road and Bates Brook on Main Street in Lakeville and Miller's Neck Brook on Miller Road in Middleborough. These streams are all tributaries to the Assawompset Pond Complex. Tamett and Bates Brooks flow into Long Pond. Long Pond is a source of drinking water for the City of New Bedford. Miller's Neck Brook is a tributary to Black Brook which flows into Great Quitticas Pond.

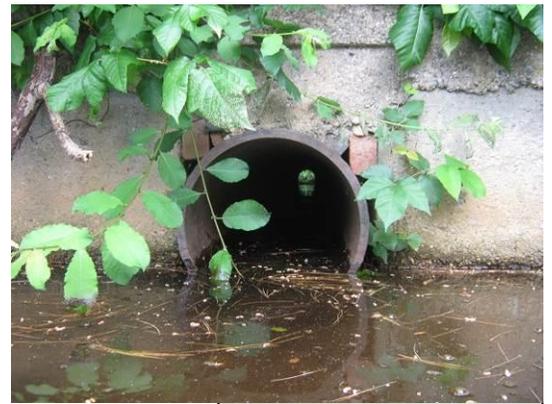
Walker Street in Norton

5. A crossing of a **tributary to the Wading River at Walker Street in Norton** is a single round culvert embedded or with persistent water. The culvert is in poor condition with severe constriction, large scour pool and skewed alignment. There is an outlet drop of 2" to water surface and 6" to streambed. Improvement of aquatic passage at this crossing could result in significant benefit because of its location of this crossing on a major tributary with a large drainage area upstream in Mansfield and Foxboro.

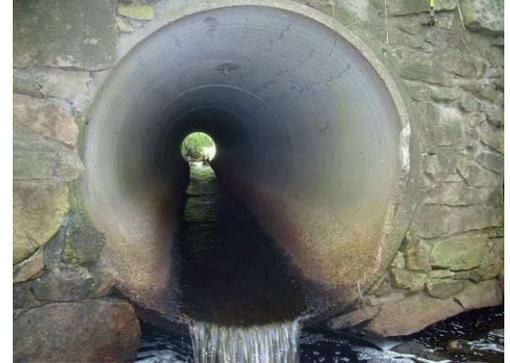
Howland Road in Freetown

6. A crossing of a **tributary to the Assonet River on Howland Road in Freetown** received an Aquatic Score of 0.46. This crossing lies in an area that could provide a permanent connection between Mass Audubon's Cedar Swamp Sanctuary and the Fall River/Freetown State Forest and Southeastern Massachusetts Bioreserve. The crossing consists of two round culverts. There is a large scour pool. An outlet drop at Culvert 1 was measured as 10" to water surface and 23" to streambed, and at Culvert 2, 9" to water surface and 29" to streambed.

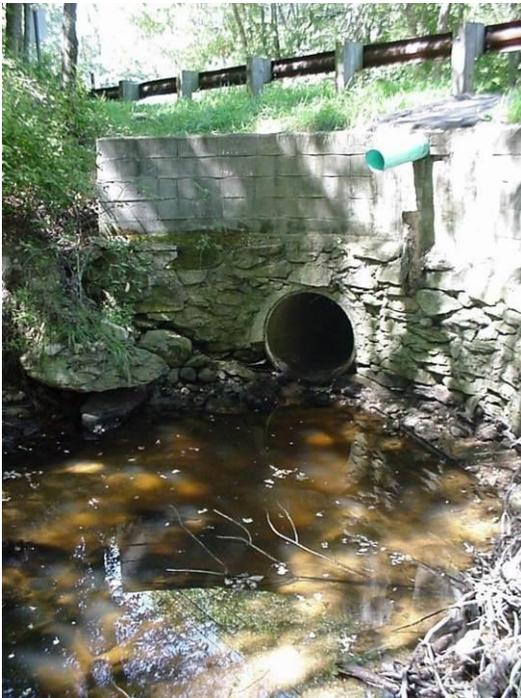
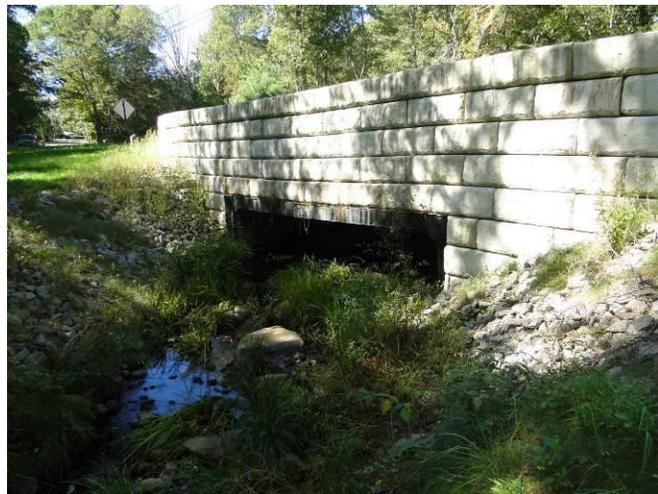
*The culvert at Hill St. in Raynham, before (L) and after (R).
Photo credit: Bill Napolitano*

The Division of Ecological Restoration’s (DER) report on the project estimated that the cost to Raynham of an “in-kind” replacement of this culvert -- i.e., no upgrade -- would include \$120,000 for a 25-year replacement plus annual maintenance cost of \$9,000. Over thirty years, this cost would total \$390,000. The savings to the town from the culvert upgrade was estimated between 75-82%.
